FINAL REPORT
on
ACCIDENT INVESTIGATION
of
9N-AME (CRJ 200LR, MSN 7772) Aircraft
Operated
by
Saurya Airlines Pvt. Ltd.
on
July 24, 2024

Aircraft Accident Investigation Commission

July 14, 2025

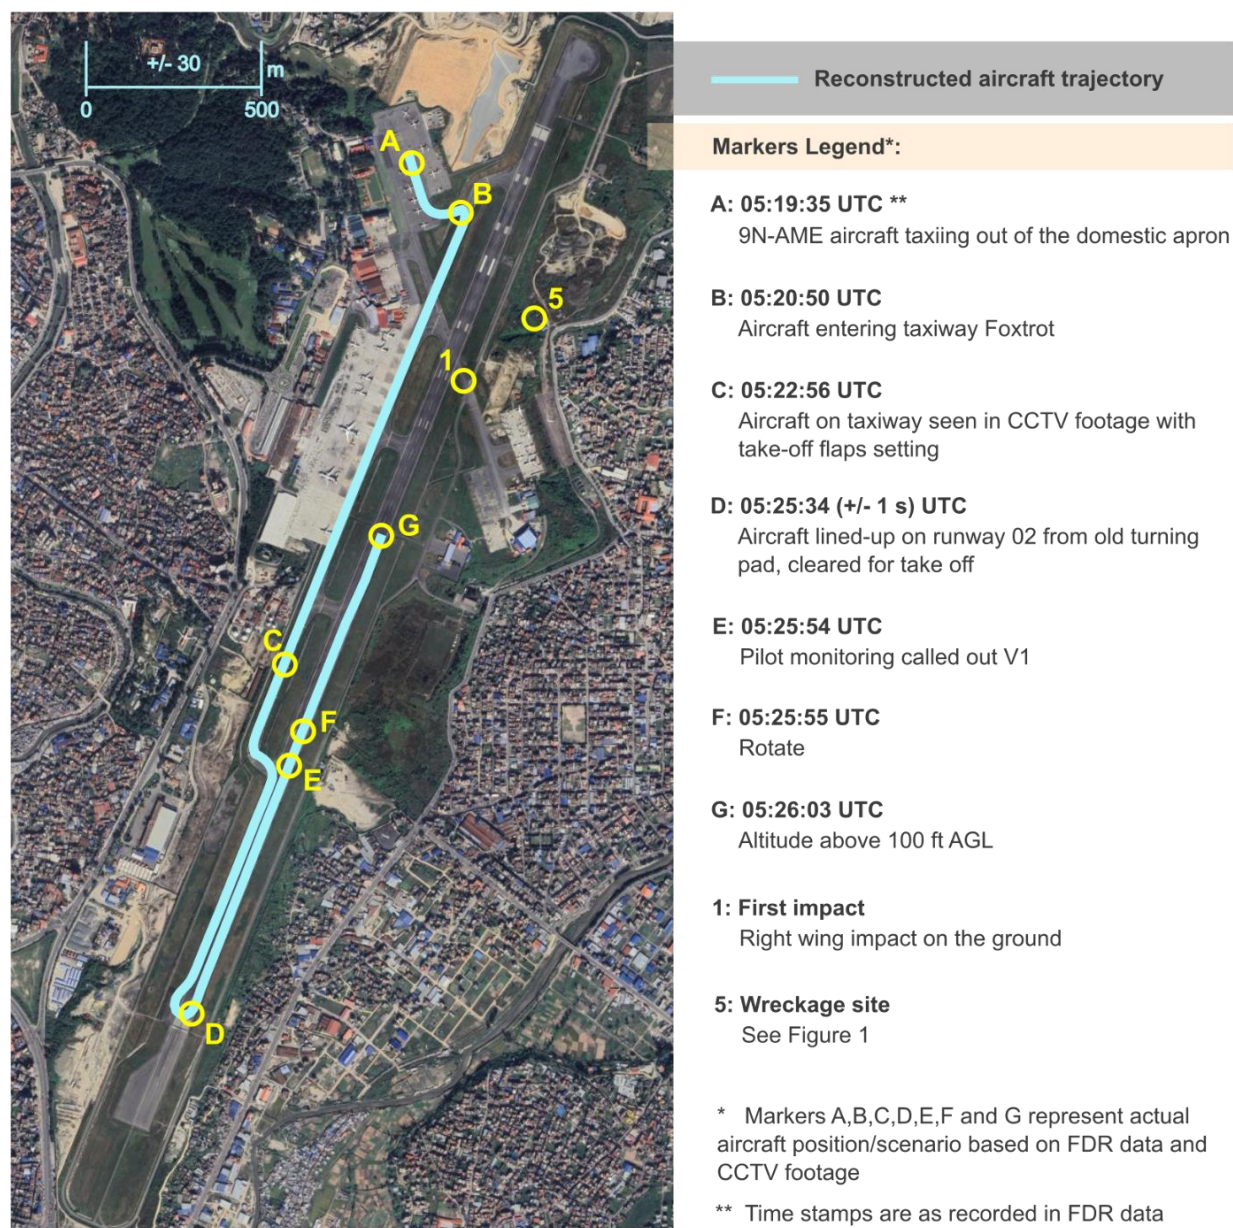
Figure 1: Flight path and event markers

The reconstructed path of the aircraft is shown in Figure 1. The figure includes the marking on the flight path significant to the comparative observation of the aircraft based on FDR data, CCTV footages, significant CVR audio information, and terrain references. Figure 2 shows the markers C and F as seen in the CCTV footage, while Figure 3 shows the unusual attitudes of the aircraft after take-off leading to the accident. The aircraft underwent a right, left and right bank before the right wing impacted on the ground at '1'.

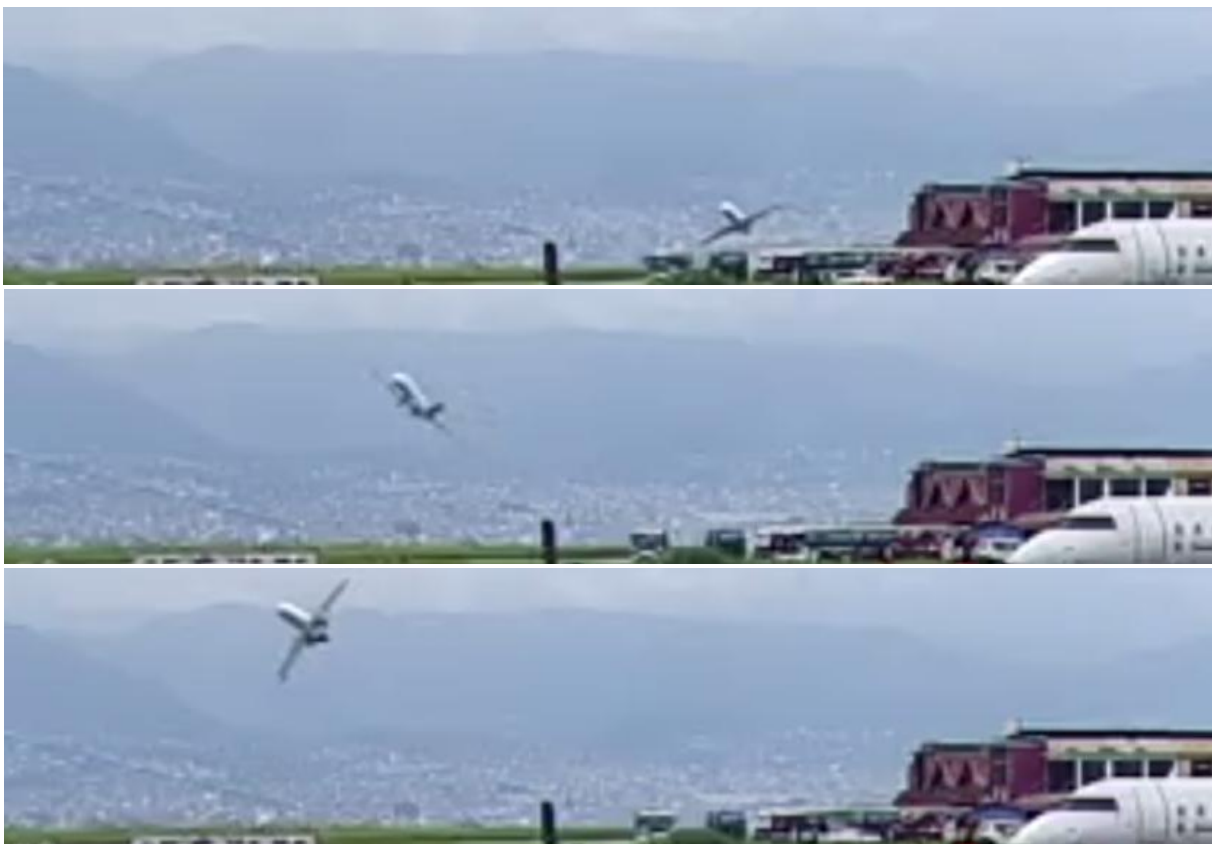
Figure 3: Event sequence with unusual attitudes leading to the accident, captured by a CCTV camera

After rotation for takeoff at 05:25:55 UTC, the aircraft attained a height of 50 ft above ground level (AGL) within around 5 seconds. Based on the height computed from inertial data, the aircraft attained a height of slightly above 100 ft AGL by 05:26:03 UTC (marked 'G' in Figure 1). At 'G', the aircraft was at 94.6° roll angle with a heading of 24.7°, veering right of Runway 02.

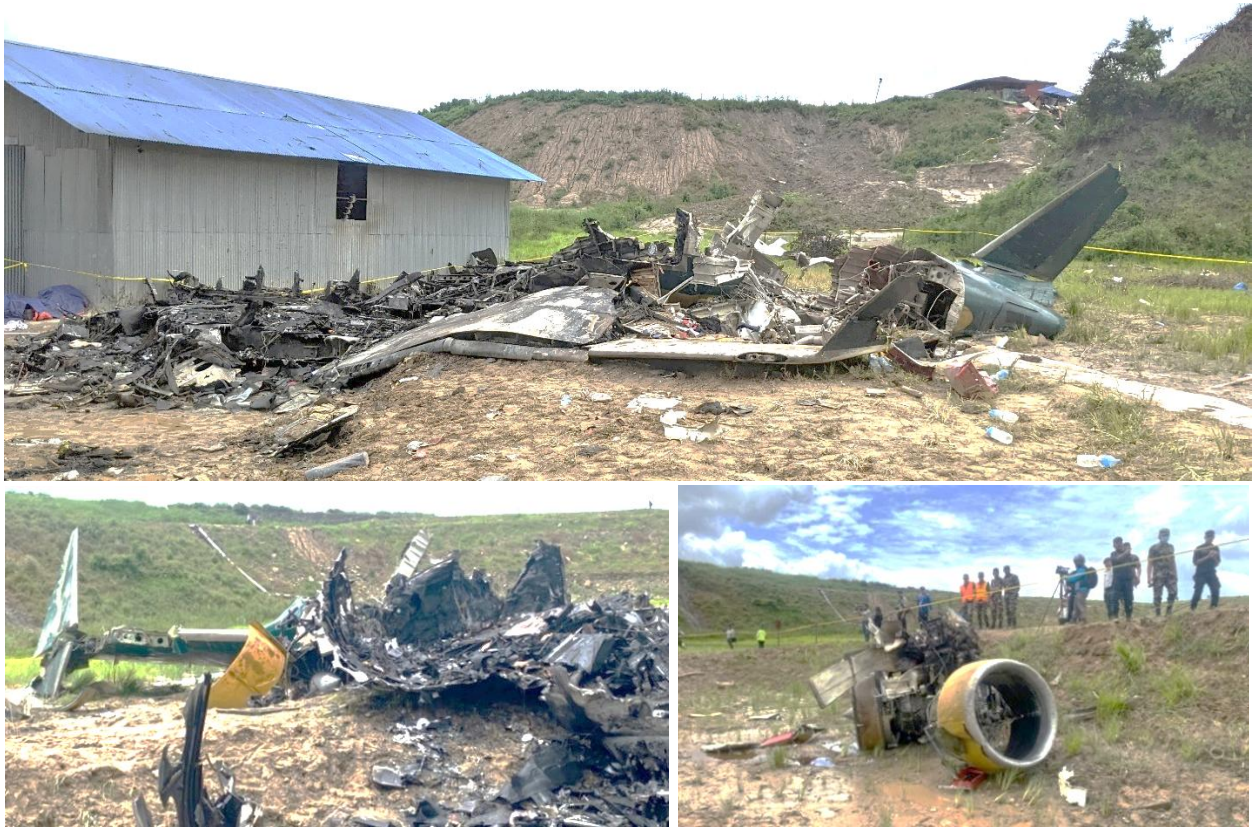
The aircraft was destroyed due to high velocity impact, and post impact fire as seen in Figure 4. The aircraft also collided with the container and shed of Air Dynasty Heli Services Pvt. Ltd. The cockpit portion was stuck on the Air Dynasty container on the eastern side of the airport. Most of the fuselage structure and its components were damaged due to fire.

Figure 4: Top: scene at the main wreckage site, bottom: burnt fuselage and empennage sections, and the detached left engine. Images were taken on July 24 and 25, 2024.

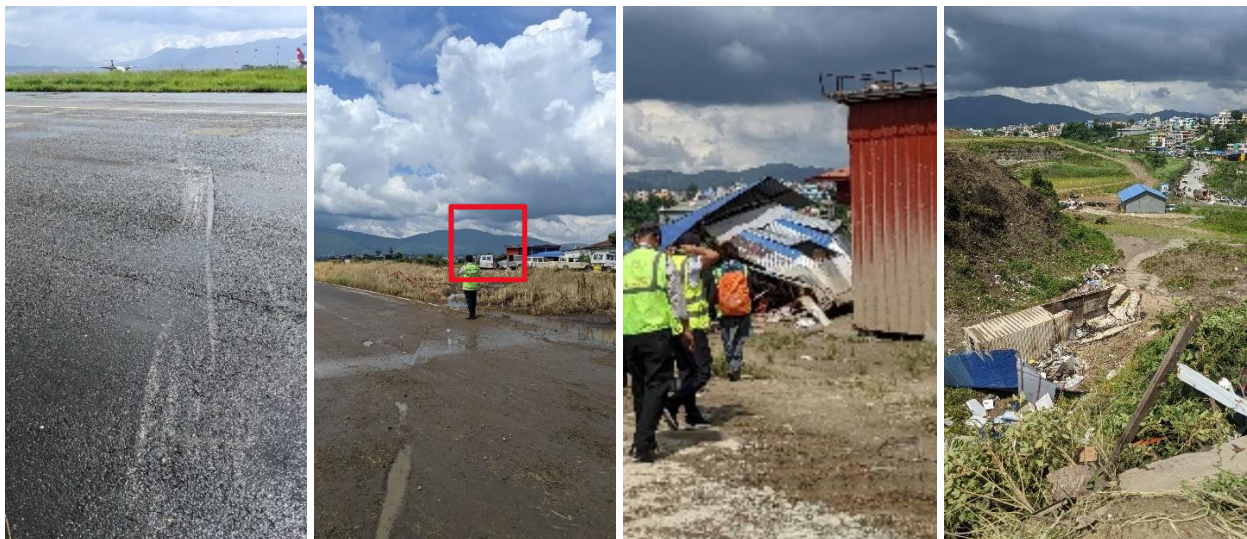
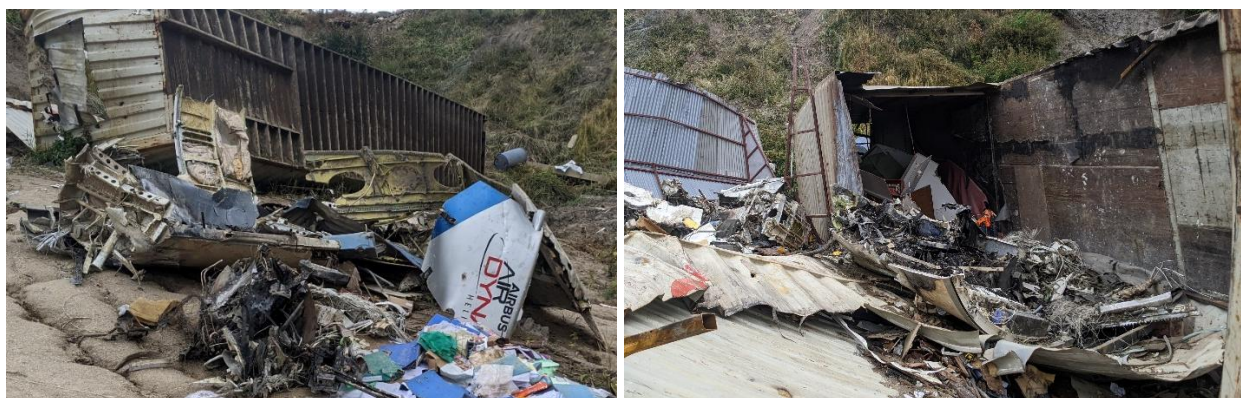
The collision of 9N-AME with the container and shed of the Air Dynasty Heli Services Pvt. Ltd. led to damage of Air Dynasty properties. Mainly, a container of Air Dynasty was dragged from its initial installation site on the eastern side of the airport. It was partly destroyed during the impact and further taken apart during the rescue efforts from the 9N-AME cockpit. A shed at the Air Dynasty site was also damaged. The airport ground infrastructure along the aircraft's distraction track was also damaged during the impact of the right wing and subsequent fire. Images of this damage are shown in Figure 5.

The components of the 9N-AME aircraft cockpit and other systems and avionics were scattered in the vicinity of the Air Dynasty container site. These areas had a mixed wreckage from the 9N-AME aircraft and components of an Air Dynasty helicopter. These components can also be seen in Figure 5.

Figure 5: Accident site photos, taken on July 25, 2024, tracing the damage that occurred during the accident. [**Top-left:** location of first impact by the right-wing east of runway-02 top-left; **top-center-left:** trail left by the right-wing as the aircraft plummeted towards the Air Dynasty shed area seen in the background; **top-center-right:** destroyed shed of Air Dynasty, beside the red container; **top-right:** crash site looking downhill of the location of the Air Dynasty shed area; **bottom-left:** Air dynasty container dragged down-hill by the aircraft upon impact; **bottom-right:** the container where the 9N-AME cockpit was stuck, showing the wreckage remaining after RFF team had taken apart the cockpit during rescue.]

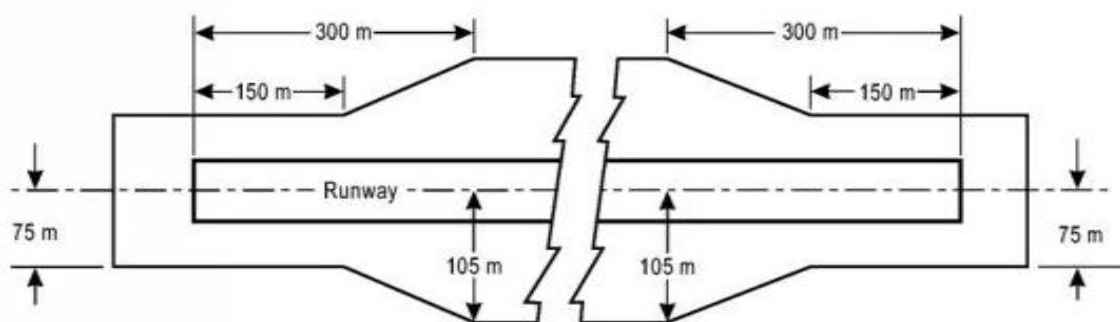
Figure 6: Graded portion of a strip including a precision approach runway where the code number is 3 or 4. [Source: ATCEP, CAAN]

In the AIP Nepal published by CAAN on November 3, 2022 (AMDT 08/2022), the runway strip is mentioned to be 280 m, which is as per the ICAO Annex 14 Volume-1 standard. However, at the site the runway strip the width was observed be only around 150 m, which is not sufficient.

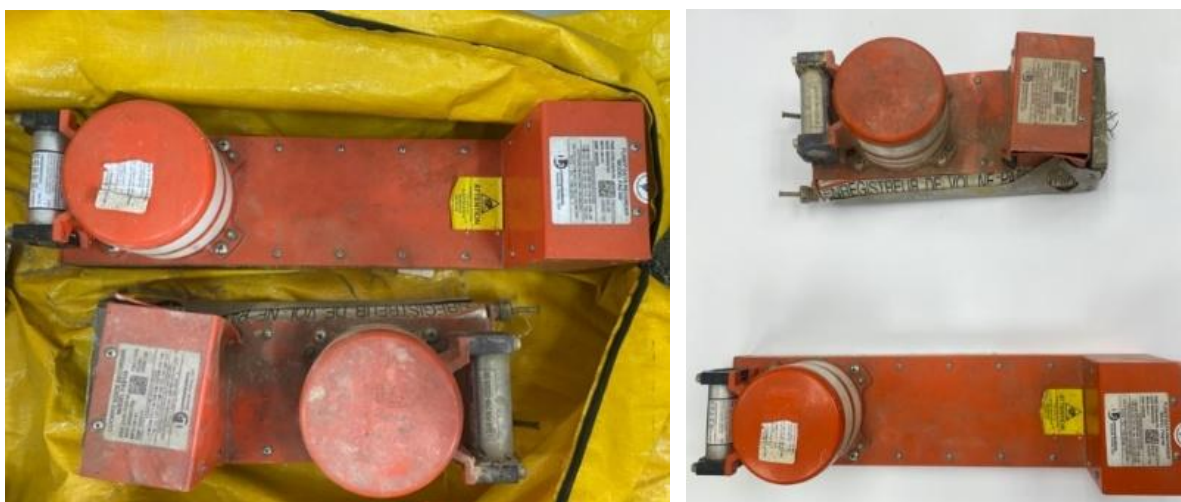
Figure 7: Condition of recorders as received by AAIC (left), and after being transported to TSIB, Singapore (right)

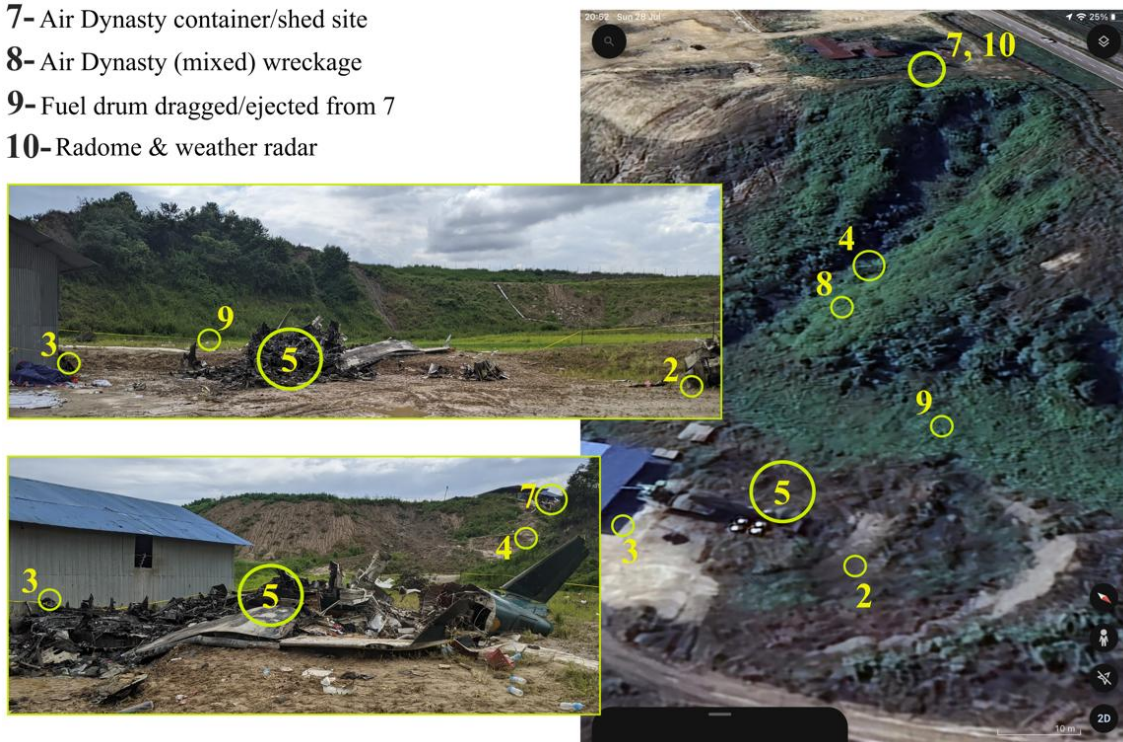
Figure 9: Overall distribution of the wreckage (see Figure 8 for markers '1' to '5')

The left engine detached from the empennage when the aircraft impacted at '5' and lay at '2'. The engine had ingested rubble, and the fan blades showed damage from impact with pebbles and other materials in the rubble. The left engine had broken off at the root of the pylon. The right engine could not be distinctly spotted among the wreckage. However, parts of nacelle and inlet cowl were located at '3', '8' and on the right of the empennage at '5'.

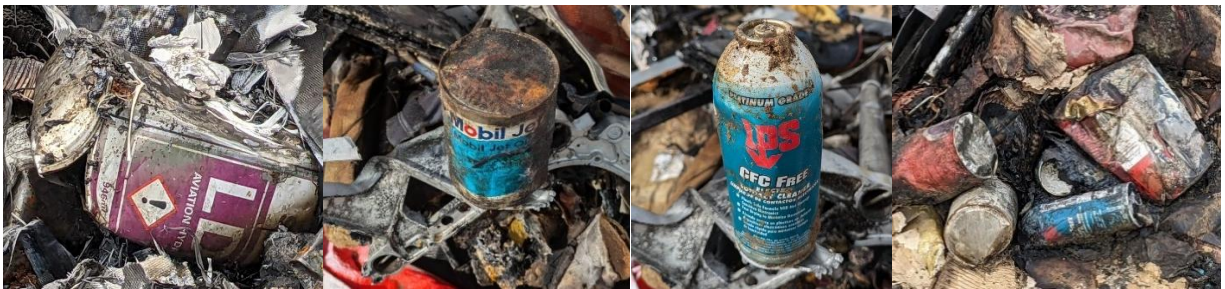
Notably, flammable fluids and other dangerous goods were also found among the wreckage. These included lubricants, hydraulic fluid, engine oil, contact cleaner, etc. Figure 10 shows the items found at the wreckage site. The LPS contact cleaner was identified as a dangerous good (UN1950; hazard class: 2.1; aerosols; flammable).

Figure 10: Hydraulic fluid and some flammable items found at the wreckage site

Saurya Airlines did not have a dangerous good permit and was not authorized to carry dangerous goods onboard. Given the nature of haphazard loading of the aircraft, the possibility that the items

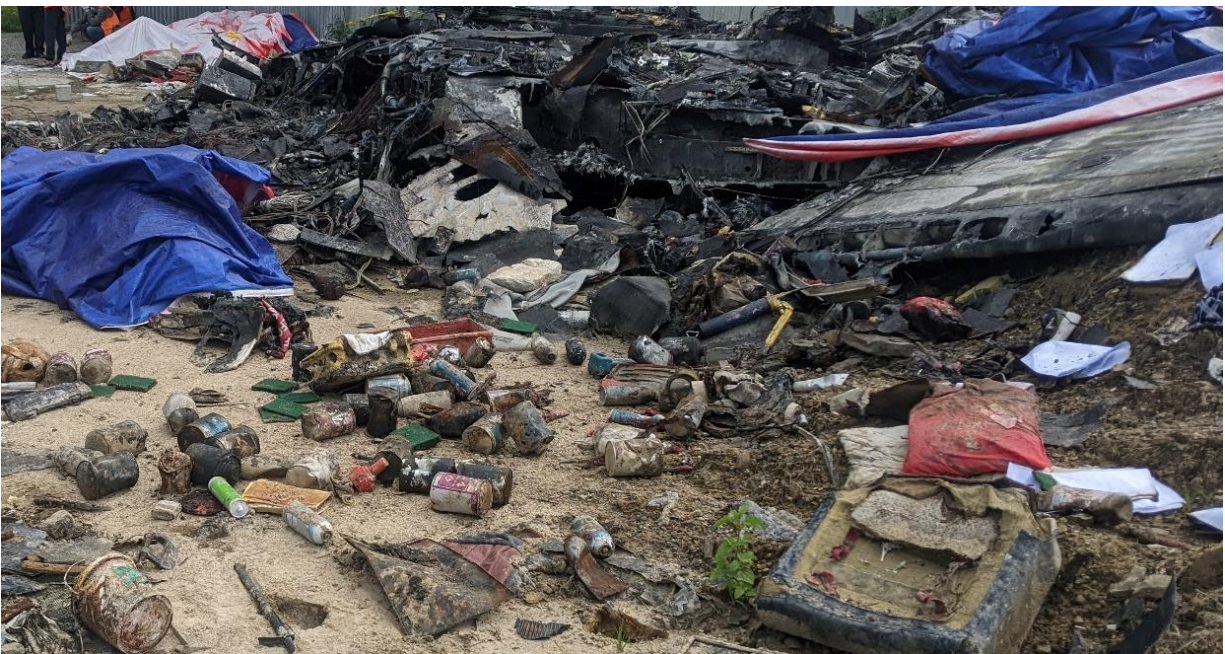
Figure 11: Wreckage site at marker '5', with recovered containers of fluidic items

were not present in the cabin during the event flight cannot be ruled out. The Commission recovered many of such items' containers from the cabin section of the wreckage. It should be noted, however, that these items may have been either ejected or moved during the rescue operations. The Commission also spotted hydraulic fluid spread on the floor of the burnt-down cabin of the aircraft at the wreckage site. Figure 11 shows the wreckage at marker '5' and some of the fluid containers recovered from the cabin and cargo section.

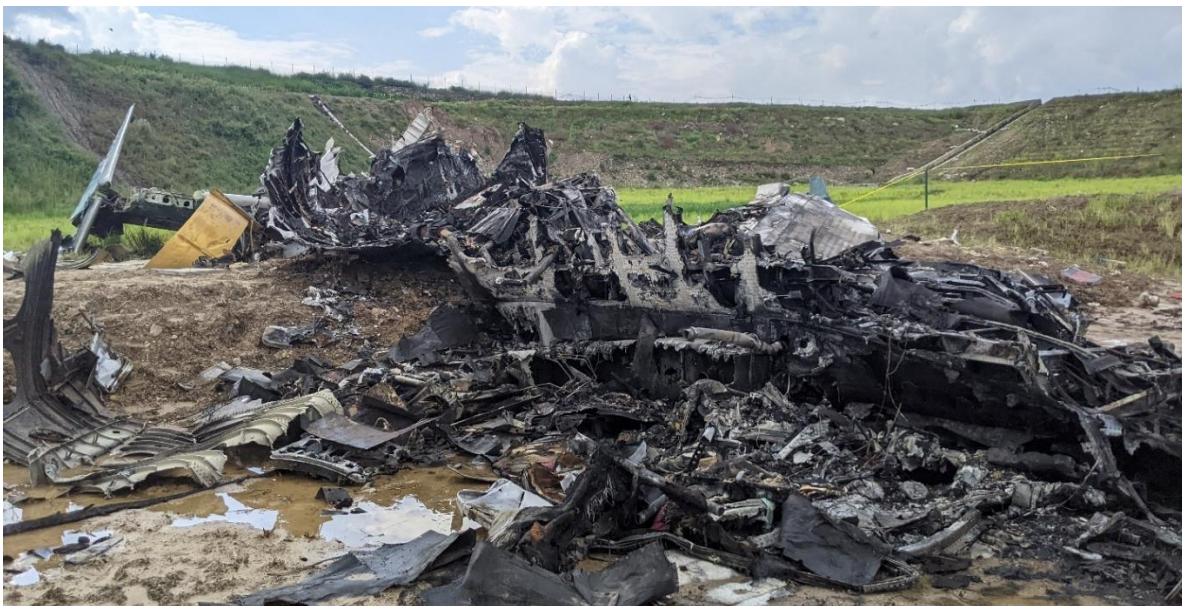
A particular scenario observed at the wreckage at '5' was the nature of destruction of the entire front fuselage section. Aft until the empennage, the fuselage was burnt down to the cabin floor, as shown in Figure 12. Few parts from the fuselage outer structure were found at the wreckage site, for e.g., the skin panel seen near the center upper-half of Figure 11. This indicates the possibility of several simultaneous factors:

3. The RFF effort was not swift enough to control the fire from engulfing the cabin wreckage at '5'. While some of the fuselage structure was taken apart during the rescue efforts, the wreckage shows fire damage of an extensive nature, indicating that the fire in the cabin had been burning long enough to cause the extensive damage seen in Figure 12.

4. The presence of flammable items onboard exacerbated the fire situation in the cabin.

Figure 12: Fuselage wreckage at marker '5' as seen from the front of the cabin

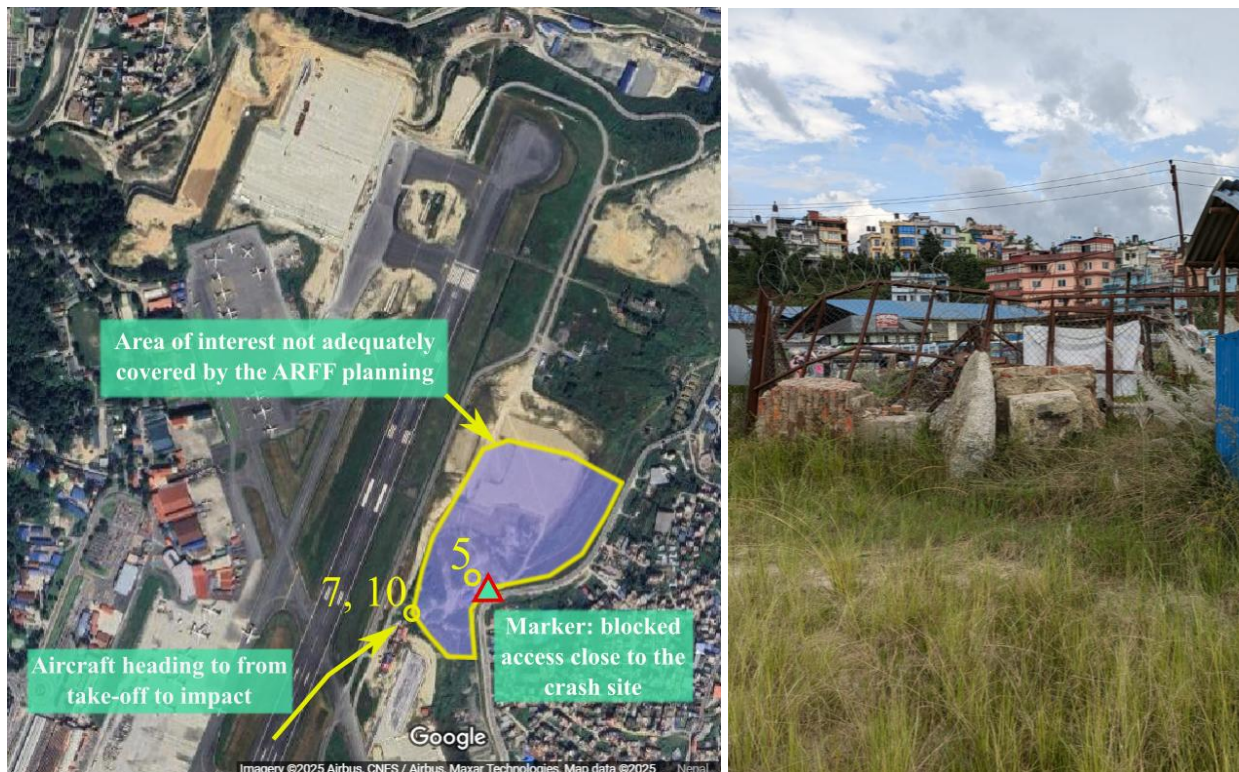
One of the emergency access gates closest to the crash site was found closed and obstructed by construction materials and debris. No Safety Risk Analysis or Management of Change process was completed for this area, contributing to deficiencies in the rescue operation. The blocked-off emergency gate can be seen in Figure 13, and among the site images provided in Appendix 7.

No Task Resource Analysis was conducted for equipment and manpower resources as per ICAO Service Manual 9137 - Part 1 and the TIA Airport Services Manual to provide a Category-IX airport firefighting service. It was noted that there is a lack of training in the Safety Management System within the Airport Rescue and Fire Fighting unit of TIA. In particular, blind regions were found in the coverage of the airport area. The assessment of the crash site by the Commission revealed that, despite being within the airport premises, the crash site was difficult to access on foot and via ground vehicle. These details are shown in Figure 13.

Figure 13: Blind region in the area of interest that hindered effective rescue and firefighting efforts. The markers 5, 7 and 10 are as listed in Figure 9. The blocked access marked near 5 is shown on the right.

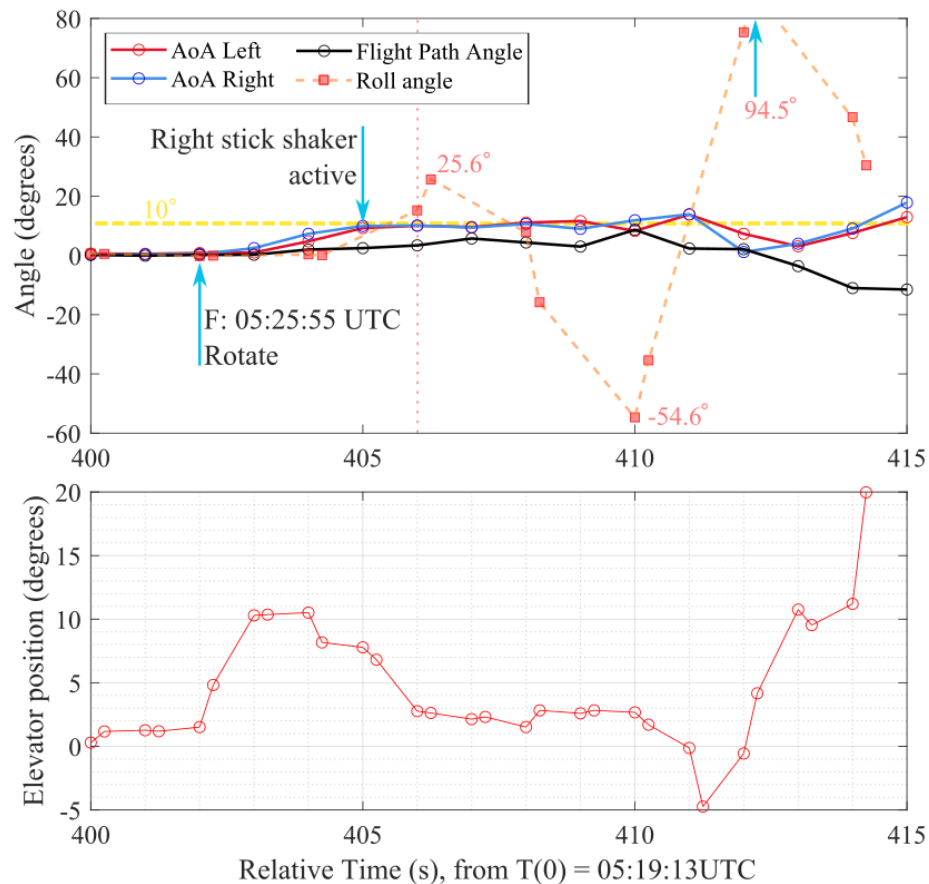
The aircraft rotated for take-off near 120 knots. This speed fell short from required rotation speed stated in Tables 15 and 16. The elevator deflection (up) for take-off went from around 1.5° to 10° within 1 second. Two seconds after the elevator deflection to ~10°, the angle of attack of both wings reached around 10°. At this instance, the aircraft started undergoing a right-low roll motion and the right stick shaker became active. Both stick shakers became active 1 second later, while the right-low bank angle reached 25°. This sequence is shown in the Figure 16. The instance where both stick-shakers became active is at 406 s in the figure, marked by a vertical dotted line.

Figure 16: Flight angles and left elevator (up) position

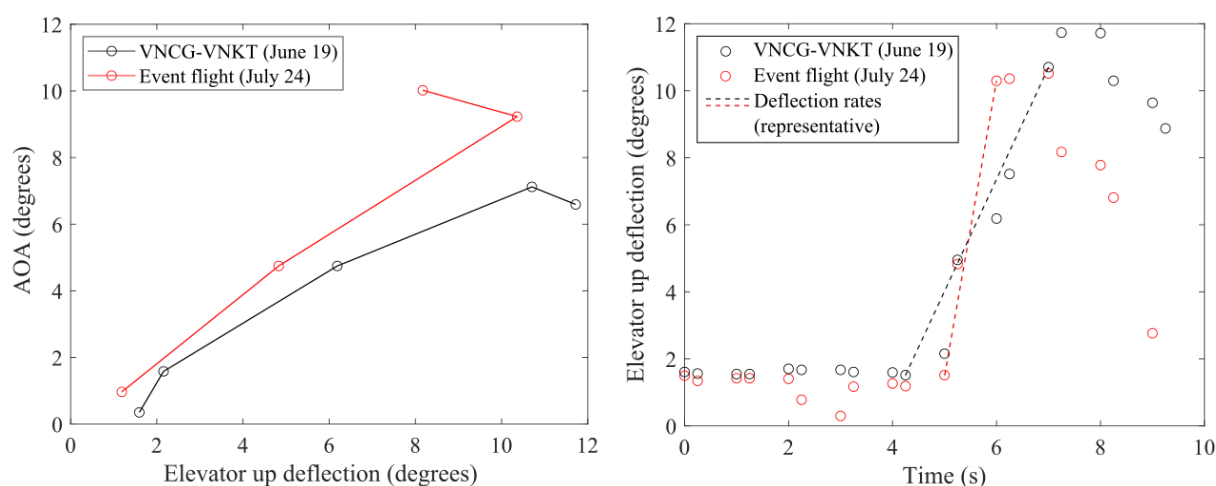
The response of the aircraft's rotation for take-off with respect to elevator deflection is analysed in Figure 17. In the responses shown, the angle of attack is taken 2 seconds from the corresponding elevator deflection. Response for the event flight shows that although the elevator deflection was decreased at an angle of attack of near 10° , the angle of attack continued to increase. This is unlike the comparison case, indicating that the longitudinal (pitch) control had been lost within 3 seconds after rotation.

Figure 17: Elevator and airplane pitch responses. The angle of attack is for the left wing.

The reason for a rapid increase of pitch angle (mainly the angle of attack component for the first few seconds) can be attributed directly to the rapid rate of elevator deflection, as shown in Figure 17. During the rotation for take-off, the elevator deflection for nose pitch up attained a deflection angle of over 10° in 1 second. Discounting the approximately two-seconds time lag in the aircraft response, the left-wing angle of attack increased linearly from approximately 1° to 10° within 2 seconds. During this period, the right-wing angle of attack rose more rapidly than that of the left wing, as seen in Figure 16. Hence, the right stick shaker also activated first, followed by the left stick shaker becoming active after 1 second.

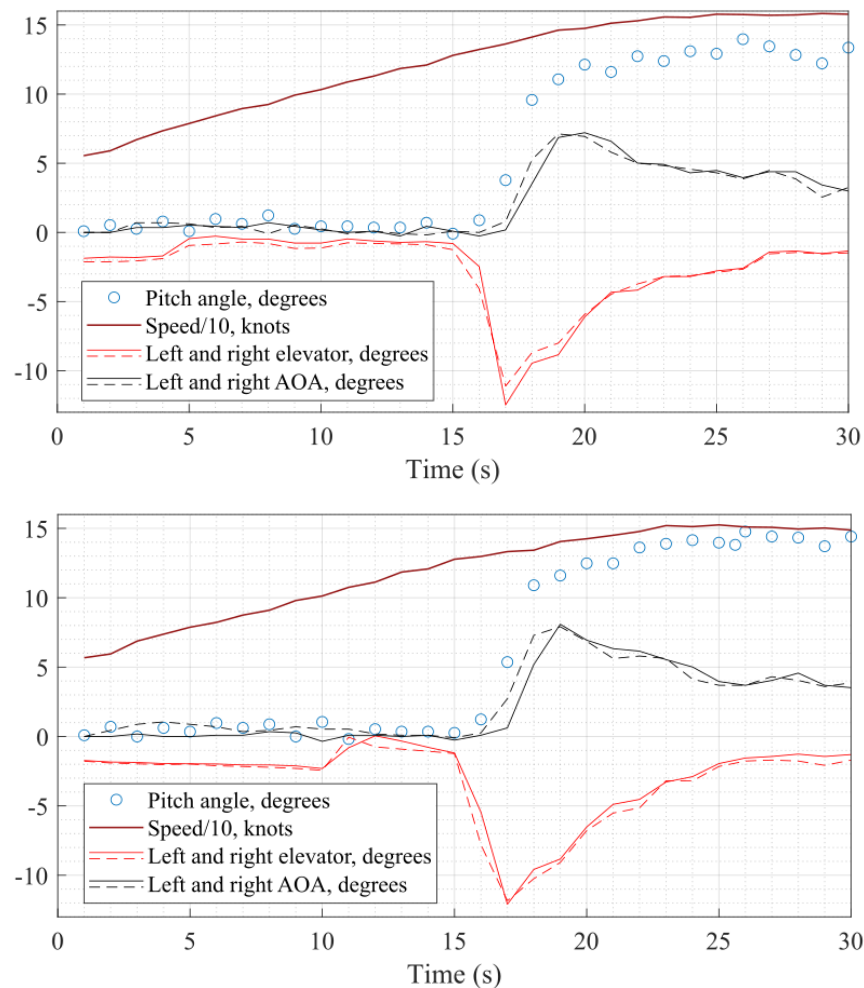
The worse of these cases for 9N-AME happened during flights on 11 January 2024 and 19 March 2024, with the rotation rates as per the above criterion respectively as (5.8° /s, 4.35° /s) and (5.5° /s, 4.8° /s). The plots showing these rotation rates versus time, along with the elevator deflections, AOA and speed are shown in Figure 18. During the flight on January 11, the elevator deflection was commanded by around 8 degrees within 1 second, because of which a rapid pitch rate of 5.8° /s was achieved between 17 to 18 seconds in the figure. While on March 19, the elevator deflection was commanded by 11 degrees in 2 seconds that resulted in a maximum rotation rate of 5.5° /s. Rotation for the flights were performed at 132.25 knots and 127.75 knots computed airspeeds, respectively. The corresponding required rotation speeds were 130 knots and 127 knots. Unlike in the case of the event flight, the above cases rotated at sufficient rotation speeds.

Figure 18: Take-off rotation data for 9N-AME flights on January 11, 2024 (top) and March 19, 2024 (bottom) that show excessive rotation rates during take-off

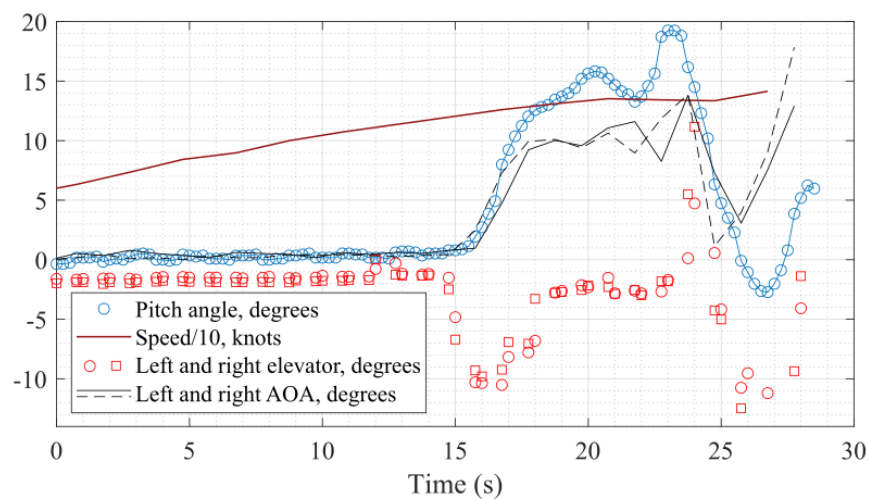
Figure 19: Take-off rotation data for the event flight, shown in comparison to Figure 18

For comparison, the elevator deflections for the event flight are shown in Figure 19. Elevator up is recorded as negative value in FDR. The rates for the event flight are abnormally high- even in comparison to the cases presented in Figure 18. In the event flight, the elevator deflection was commanded from $\sim 1^\circ$ to $\sim 10^\circ$ distinctly within a second, which is made clearer by the marker symbols in the plot style. This rate of pitch up response commanded was higher than any cases studied under this analysis, at $(6.5^\circ /s, 4.2^\circ /s)$ based on the above criterion.
