FINAL REPORT
on
ACCIDENT INVESTIGATION
of
9N-AME (CRJ 200LR, MSN 7772) Aircraft
Operated
by
Saurya Airlines Pvt. Ltd.
on
July 24, 2024

Aircraft Accident Investigation Commission

July 14, 2025

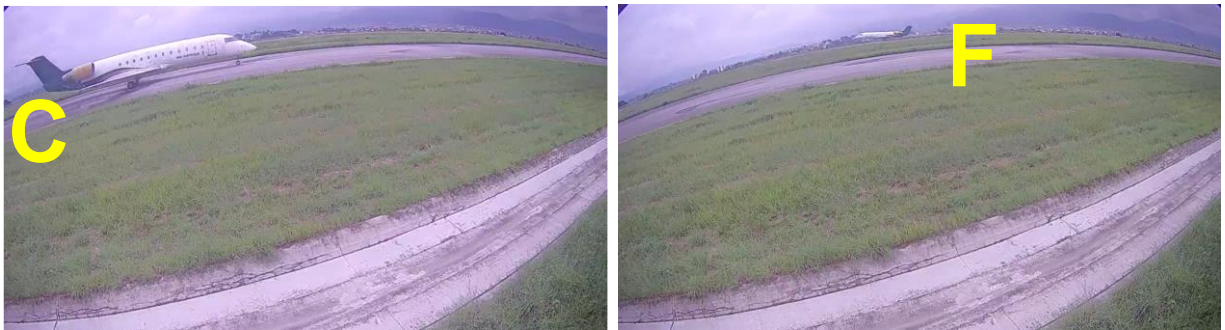
Figure 2: CCTV footage view of the events marked **C** and **F** in Figure 1

The reconstructed path of the aircraft is shown in Figure 1. The figure includes the marking on the flight path significant to the comparative observation of the aircraft based on FDR data, CCTV footages, significant CVR audio information, and terrain references. Figure 2 shows the markers C and F as seen in the CCTV footage, while Figure 3 shows the unusual attitudes of the aircraft after take-off leading to the accident. The aircraft underwent a right, left and right bank before the right wing impacted on the ground at '1'.

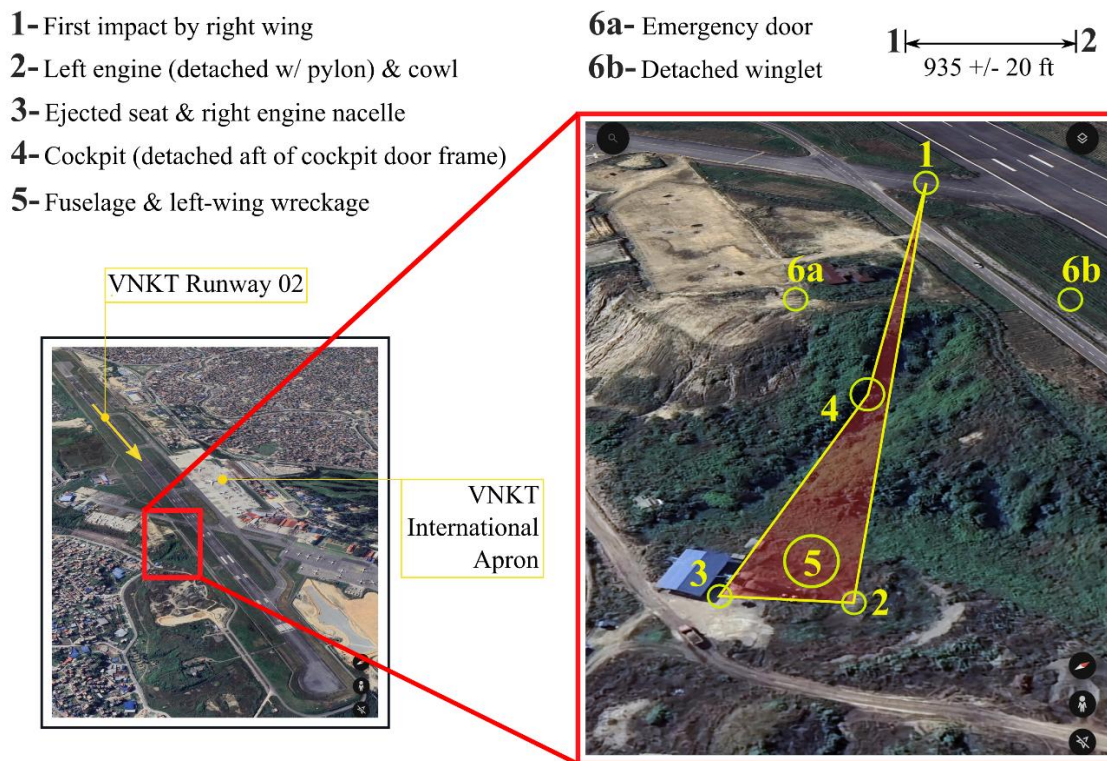
Figure 8: Site corners showing the initial impact and distribution of the crashed aircraft

The sequence of the crash marking the wreckage distribution is shown in Figure 8. The right wing first impacted on the ground at '1' (at around 05:26:10 UTC), marking the start of the disintegration of the right wing and the subsequent crash. In addition, the following markers represent the location of the wreckage components:

At the main wreckage location, marked '5', the left wing and empennage lay seemingly attached to the fuselage. The portion above the cabin floor was completely burnt-off due to fire. The cargo compartment was destroyed and the baggage in the compartment had largely fallen off to the left of the aircraft. The fuselage of the aircraft rested on a slightly right bank position, with the elevator deflected up and rudder deflected left.

- 7- Air Dynasty container/shed site
8- Air Dynasty (mixed) wreckage
9- Fuel drum dragged/ejected from 7
10- Radome & weather radar

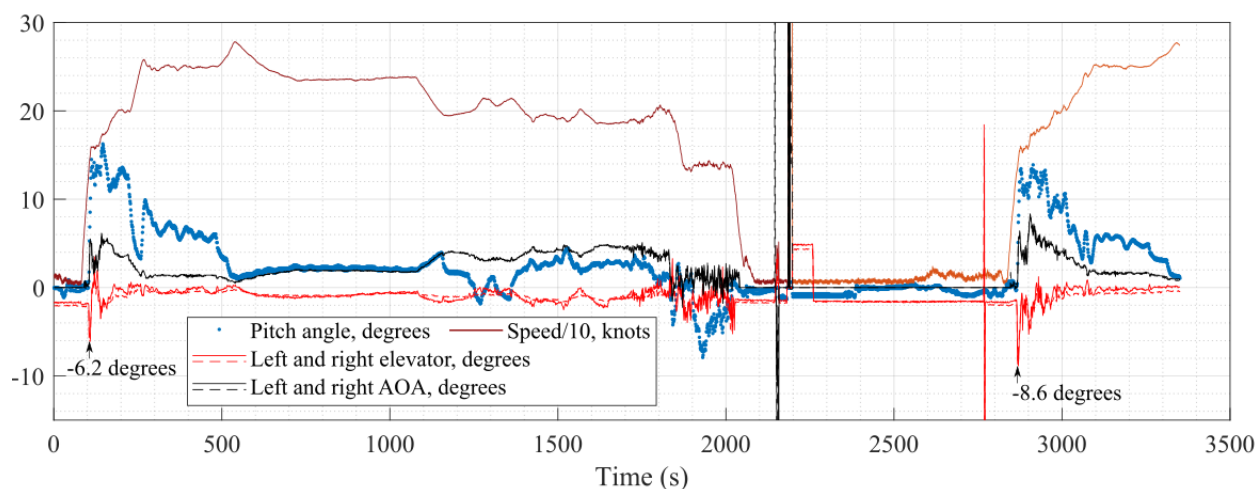
Figure 14: Flight parameters of typical flights (first flight from 0 s to ~2100 s and second flight from ~2800 s onwards), showing nominal elevator commands required and angle of attack and pitch angle responses during take-off and climb.

Typical flight parameters of two different flights, from February 20, 2024, are shown in Figure 14. The data presented in the figure was plotted in the same sequence as they were retrieved in the FDR, without clipping the time on the ground. The data presented is among the volume of historical flight data from the Saurya Airlines fleet that was analyzed as part of this investigation.

The rotation rates (pitch rates) in the cases presented in Figure 14 are within a nominal range of 3 degrees-per-second. The required elevator deflection for rotation ranged approximately between 6° to 10°, and the angle of attack increases approximately by up to 8°. As shown, during a typical take-off, the share of flight path angle gradually increases in the value of pitch angle, as the angle of attack should be limited within a safe range below stall margin. As the aircraft begins the climb, the pitch angle is increased to a target pitch angle, and the take-off sequence is completed. These sequences can also be interpreted from the data presented in Figure 14.

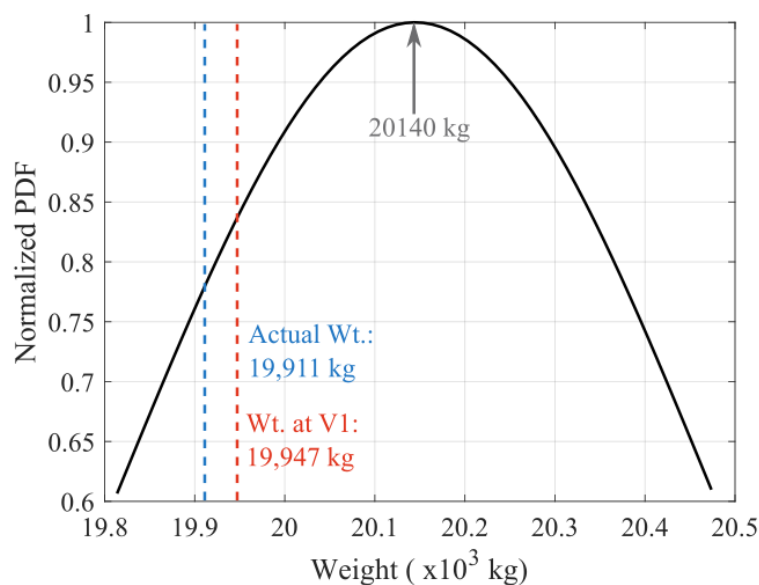
Figure A.11.1: Probability distribution function of the weight estimation ranged between of the 9N-AME flight taking off from VNCG on June 19, 2024.

The flight from VNCG in the Figure A.11.1 shows that the mean weight of the aircraft between 90 to 123 knots ($V_1 = 125$ knots) is an approximate estimate of the actual aircraft weight within an error of the order of ± 200 kg (corresponding to an uncertainty of ± 1 knot in speed). Also, the weight estimated as 19,947 kg at V_1 is the closest estimate of the aircraft weight at take-off. The same conclusion can be drawn for the data in Figure A.11.2. However, for the purpose of accounting for uncertainty of this computation method the mean values in the PDF could be referenced for a reasonable estimate of the aircraft weight at take-off, with a rounded error margin of 200 kg. The error in V-speed corresponding to the error in weight of 200 kg is approximately 1 knot.

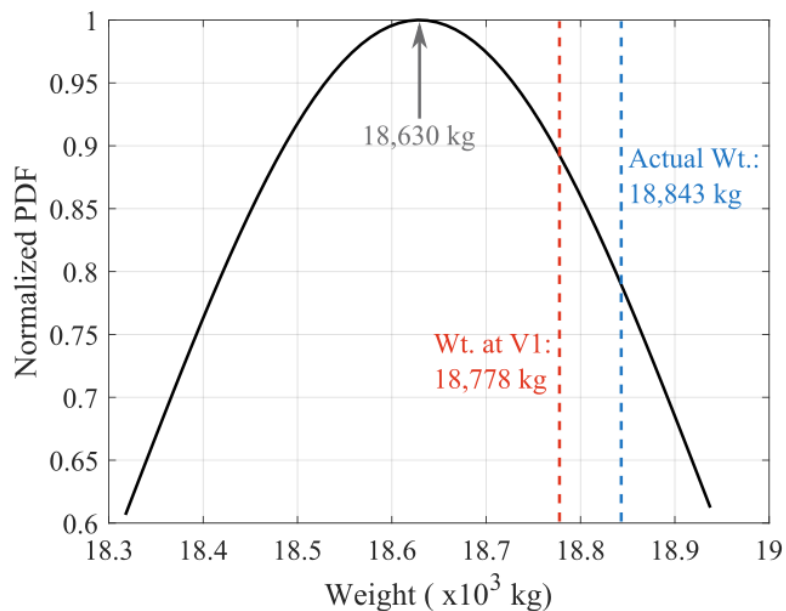
Figure A.11.2: Probability distribution function of the weight estimation ranged between of the 9N-AME flight taking off from VNVN on June 19, 2024.

The stated take-off weight of the aircraft in the load and trim sheet was 18,137 kg. Hence, the crude estimation of the aircraft weight was coincidentally close to the actual value. However, this does not imply that the weighing of baggage was done procedurally, and not weighing the baggage on board was a major lapse on the part of the ground operations and handling crew.

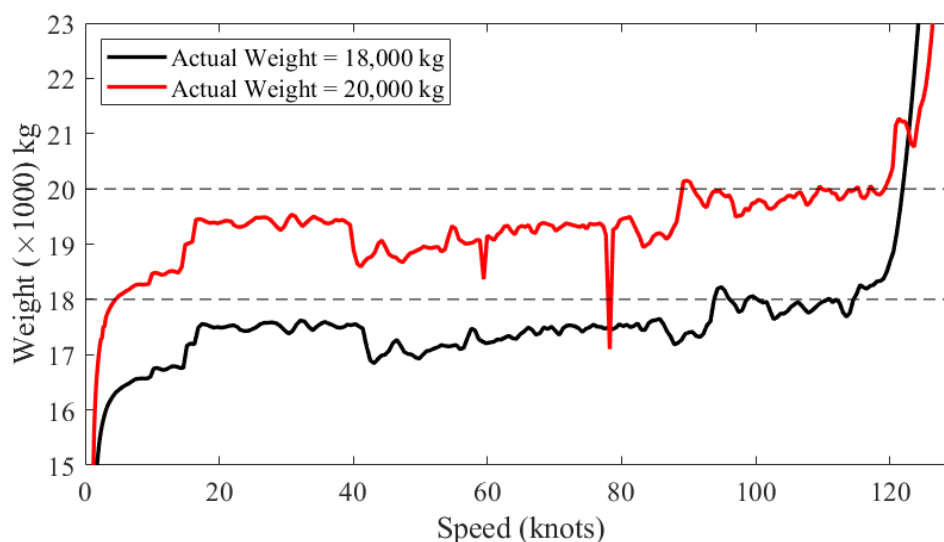
Figure A.12.1: Verification of the weight estimation method from flight simulation

The weight of a simulated CRJ-200 aircraft was calculated using the current take-off equation method using X-Plane simulator. The figure below shows that the calculated aircraft weight approaches the actual weight of the aircraft at speeds close to rotation speed.

In the data presented, the mean weight of the aircraft computed between 90 and 120 knots is approximately 17900 and 19900 kg, for actual weights of 18000 and 20000 kg, respectively.
